# 2010 FACILITIES ASSESSMENT FRAYSER ELEMENTARY

Project Data	
<b>Location Code:</b>	021
<b>Address:</b>	1602 Dellwood
<b>Year Built:</b>	1954
<b>Grade Configuration:</b>	K-6
<b>Student Capacity:</b>	460/600
<b>Ideal Capacity:</b>	467
<b>ADA Student Enrollment:</b>	0
<b>Size:</b>	54.01
<b>Portables:</b>	5
<b>Building &amp; Addition</b>	48,845 s. f.

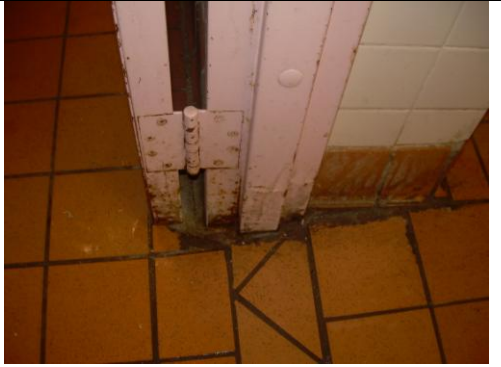
<b>Description:</b>  Door frames in the kitchen are rusting creating health department issues.

<b>Timeline:</b>  TBD	<b>Cost:</b>  \$4,700

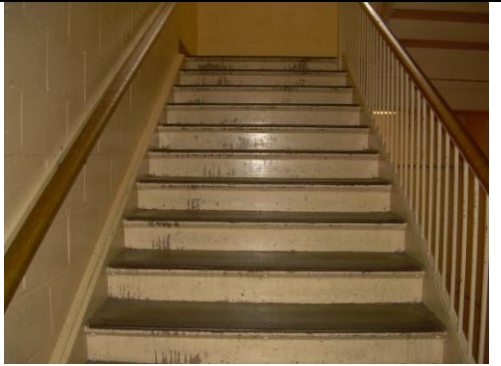
<b>Description:</b>  Stairwell treads have lost their integrity.

<b>Timeline:</b>  TBD	<b>Cost:</b>  \$17,000

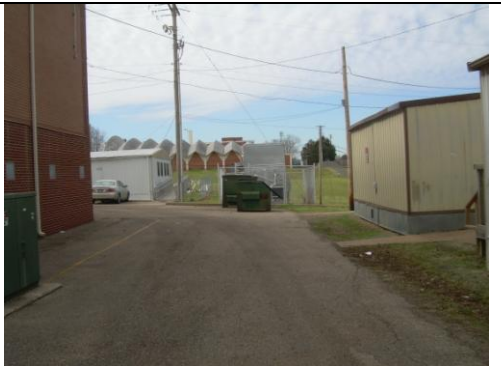
<b>Description:</b>  Dumpster needs enclosure.

<b>Timeline:</b>  TBD	<b>Cost:</b>  \$5,000

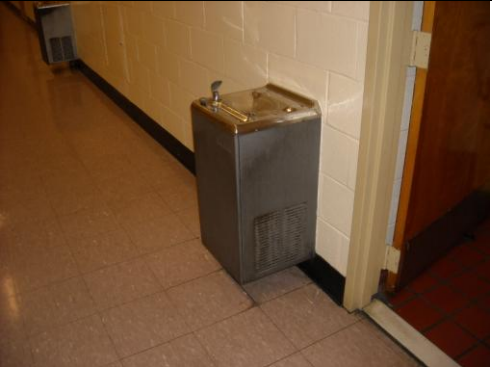
<b>Description:</b>  Upgrade to ADA guidelines

<b>Timeline:</b>  2012-13	<b>Cost:</b>  \$424,000

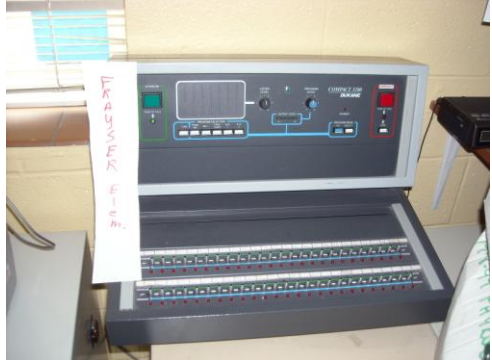
<b>Description:</b>  Intercom System  Dukane 3200  Installation Date: 2002

<b>Timeline:</b>  TBD	<b>Cost:</b>  \$50,000
