2010 FACILITIES ASSESSMENT
ROSS ELEMENTARY

Project Data	
Location Code:	291
Address:	4890 Ross Rd
Year Built:	1976
Grade Configuration:	K-5
Student Capacity:	740/1060
Ideal Capacity:	852
ADA Student Enrollment:	0
Size:	
Portables:	16
Building & Additions:	121,986 s. f.

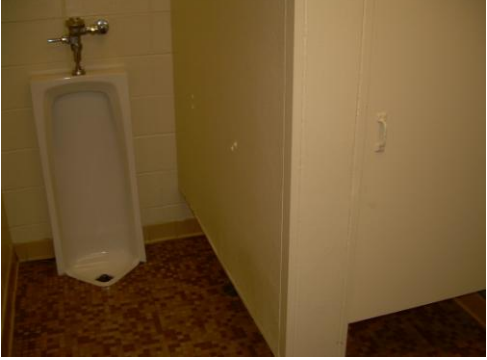
<p>Description:</p> <p>Upgrade to ADA guidelines</p>

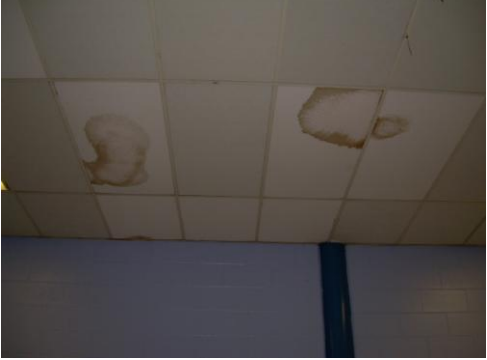
<p>Timeline:</p> <p>TBD</p>	<p>Cost:</p> <p>\$42,000</p>
<p>Description:</p> <p>See previous item</p>

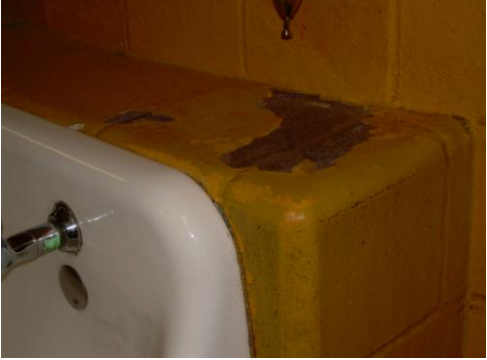
<p>Description:</p> <p>Ceramic tile in several restrooms is damaged and/or missing.</p>

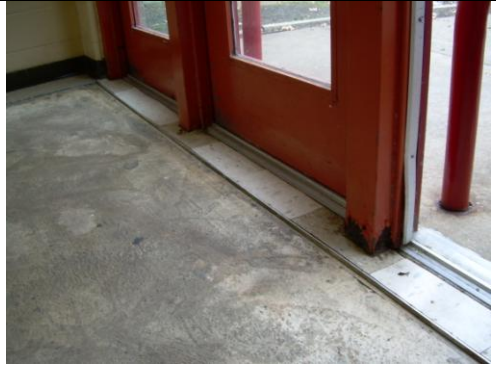
<p>Description:</p> <p>Exterior door frames are rusting</p>

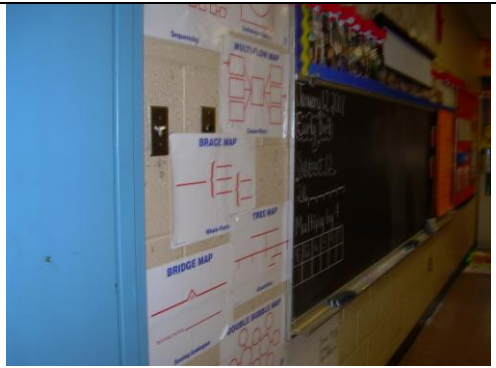
A photograph showing the exterior of a building with red-painted metal door frames. The frames are heavily rusted, particularly at the bottom where they meet the concrete floor. The ground outside is a light-colored concrete or asphalt.
<p>Timeline:</p> <p>TBD</p>	<p>Cost:</p> <p>\$58,500</p>
<p>Description:</p> <p>Whiteboards needed in some classrooms</p>

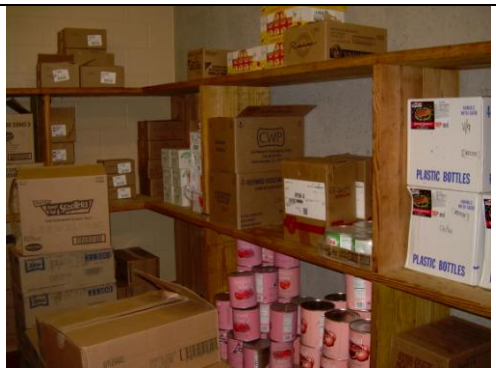
A photograph of a classroom. On the left, a whiteboard is mounted on a blue wall, displaying several hand-drawn diagrams and maps with labels like 'BRIDGE MAP', 'TREE MAP', and 'MULTI-COLOR MAP'. To the right of the whiteboard is a black chalkboard. The room is decorated with colorful items on the walls.
<p>Timeline:</p> <p>TBD</p>	<p>Cost:</p> <p>\$3,000</p>
<p>Description:</p> <p>Wooden shelves in pantry</p>

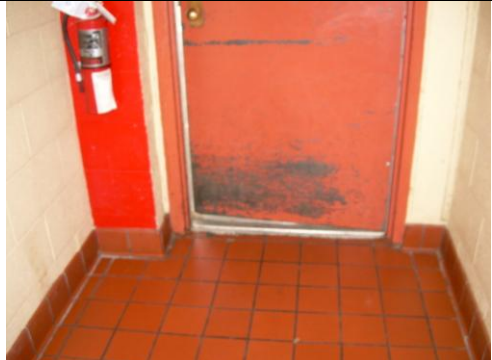
<p>Description:</p> <p>Interior paint is in fair to good condition.</p>

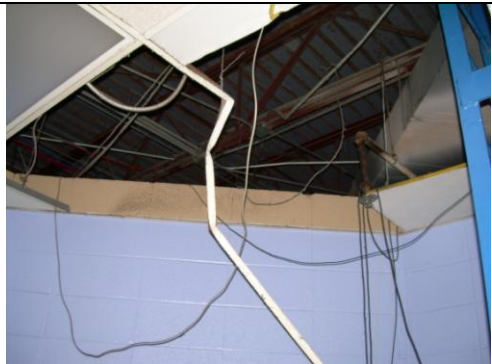
<p>Description:</p> <p>Area behind stage has damage C.T. and grid. Cable is not properly supported.</p>

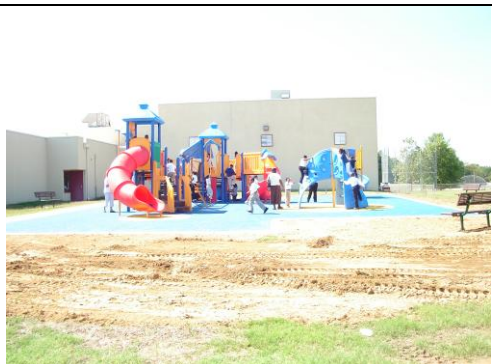
<p>Playground/Surfaces Equipment Status:</p> <p>Fully equipped Has cast in place rubber surface</p>

<p>Playground Equipment / Surface Condition:</p> <p>New equipment, good Good surface Inside courtyard not enclosed</p>

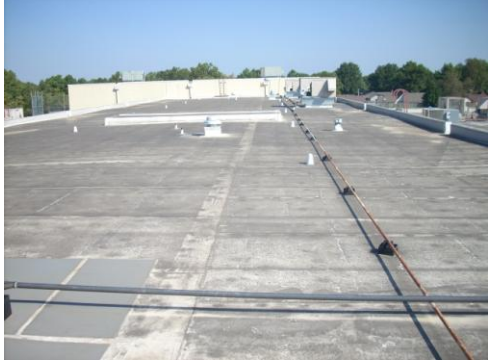
<p>Timeline:</p> <p>2013-14</p>	<p>Cost:</p> <p>\$23,800</p>
<p>Description:</p> <p>PVC single ply roof: 5 year-fair</p> <p>Shingled roof: 15 years-poor</p>
