2010 FACILITIES ASSESSMENT SHADY GROVE ELEMENTARY

Project Data	
Location Code:	058
Address:	5360 Shady Grove
Year Built:	1963
Grade Configuration:	K-5
Student Capacity:	460/500
Ideal Capacity:	403
ADA Student Enrollment:	
Size:	N/A
Portables:	2
Building & Addition	48,401 s. f.

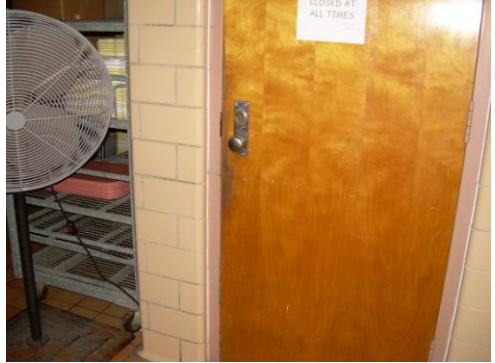
<p>Description:</p> <p>Upgrade to ADA guidelines</p>

<p>Timeline:</p> <p>TBD.</p>	<p>Cost:</p> <p>\$62,000</p>
<p>Description:</p> <p>Door frames in the kitchen are rusting creating health department issues.</p>

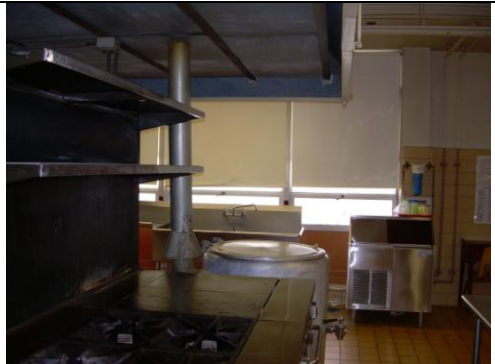
<p>Timeline:</p> <p>TBD</p>	<p>Cost:</p> <p>\$3,700</p>
<p>Description:</p> <p>Install kitchen vent-a-hood and fire suppression system.</p>

<p>Timeline:</p> <p>2010-11</p>	<p>Cost:</p> <p>\$76,500</p>

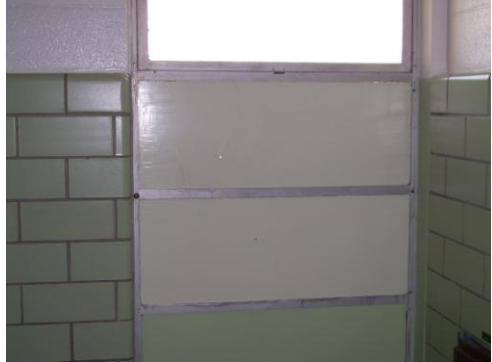
<p>Description:</p> <p>Window putty / glazing contain asbestos, windows not working properly and need replacing.</p>

<p>Timeline:</p> <p>TBD</p>	<p>Cost:</p> <p>\$375,000</p>

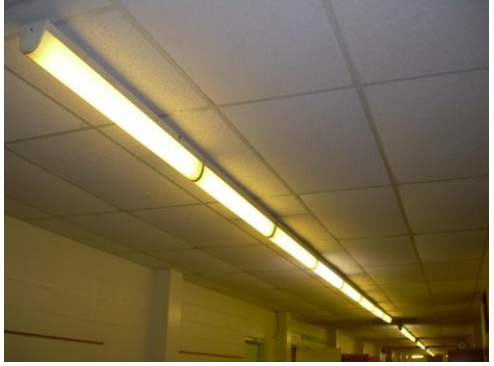
Description: Poor lighting in corridors.

Timeline: TBD	Cost: \$38,000

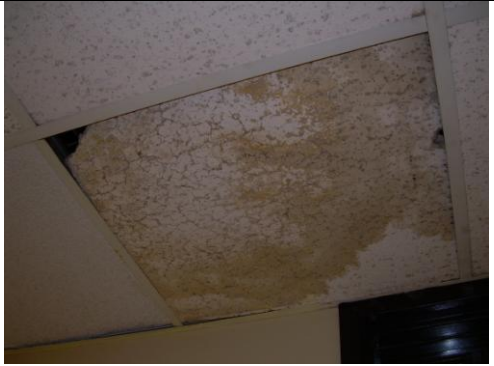
Description: Several areas of water damaged ceiling tile.

Timeline: TBD	Cost: \$7,000

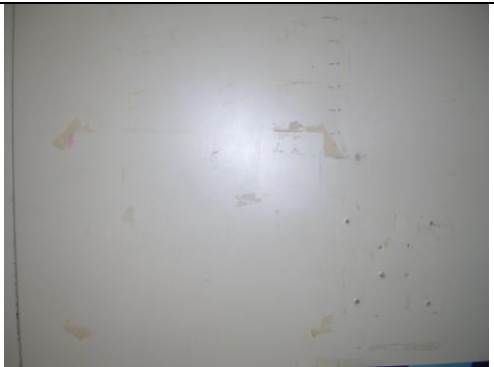
Description: Interior paint in poor condition.

Timeline: TBD	Cost: \$66,000

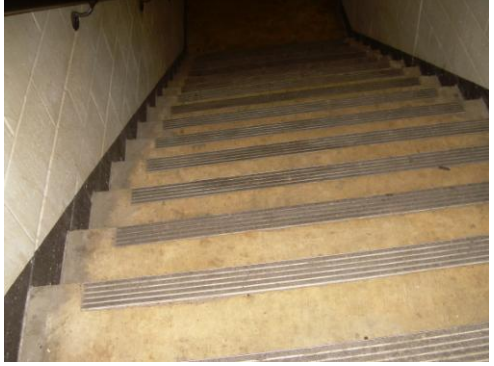
Description: Stairwell treads have lost their integrity.

Timeline: TBD	Cost: \$17,000

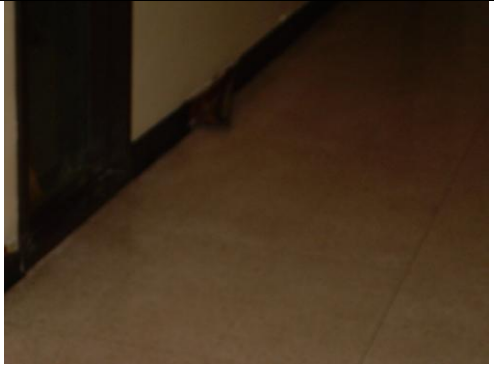
Description: Existing floor tiles contain asbestos and are in poor condition.

Timeline: TBD	Cost: \$106,000

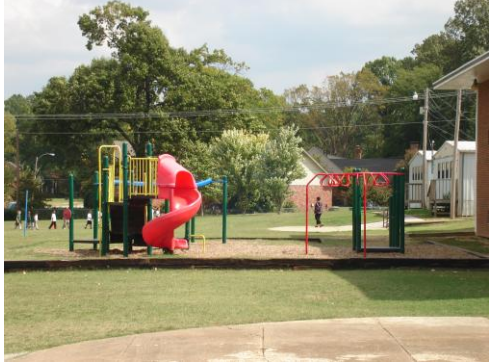
<p>Playground/Surfaces Equipment Status:</p> <p>Fully equipped Has woodchips with crossties border surface</p>

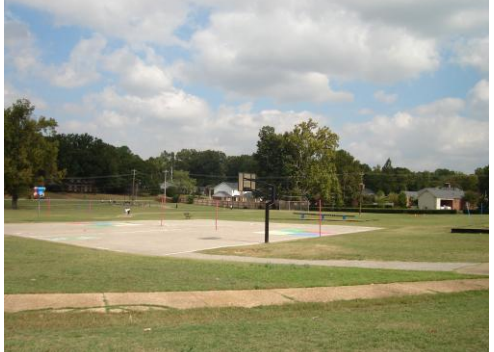
<p>Playground Equipment / Surface Condition:</p> <p>Good equipment Poor surface No fence enclosure</p>

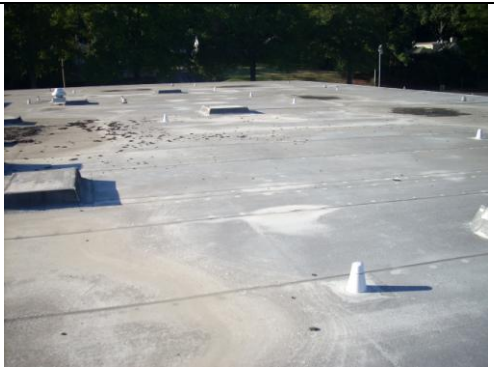
<p>Description:</p> <p>PVC Single ply roof: 6 years-fair</p>

<p>Timeline:</p> <p>TBD</p>	<p>Cost:</p> <p>\$225,000</p>

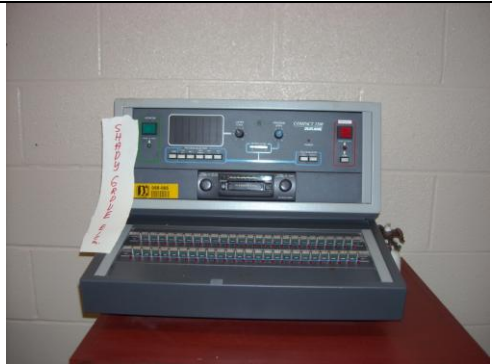
<p>Description:</p> <p>Intercom System:</p> <p>Dukane 3200</p> <p>Installation Date: 1993</p>

<p>Timeline:</p> <p>TBD</p>	<p>Costs:</p> <p>\$50,000</p>
