2010 FACILITIES ASSESSMENT
SHELBY OAKS ELEMENTARY

Project Data	
Location Code:	034
Address:	6053 Summer Ave
Year Built:	1996
Grade Configuration:	K-6
Student Capacity:	780/940
Ideal Capacity:	796
ADA Student Enrollment:	0
Size:	21 acres
Portables:	0
Building & additions	91,964 s. f.

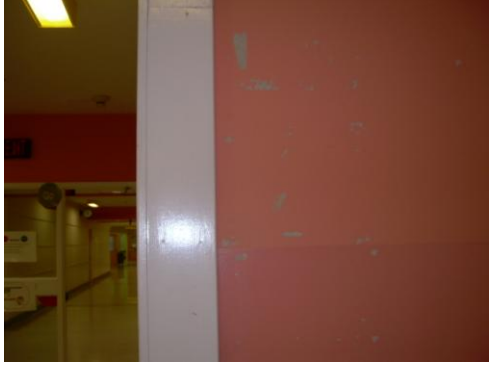
Description: Interior of school needs painting

Timeline: TBD	Cost: \$124,000

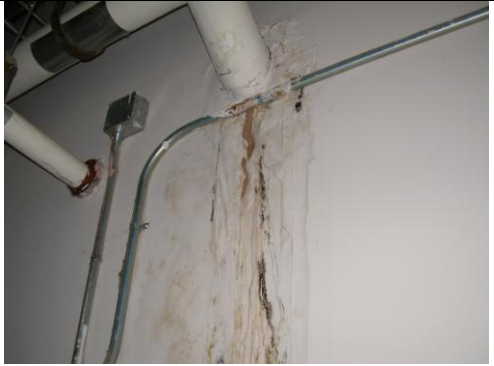
Description: Damage to walls in mechanical room.

Timeline: TBD	Cost: \$1,200

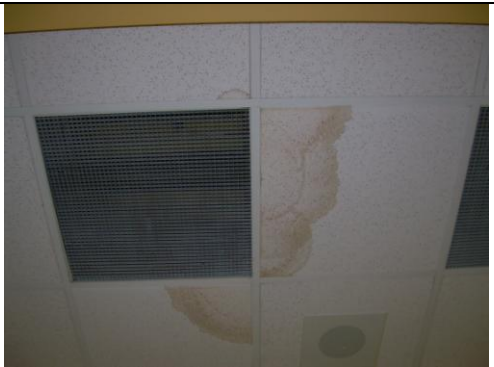
Description: Lay-in ceiling tile is in poor condition; apparent mold growth and causing potential health concerns.

Timeline: TBD	Cost: \$3,000

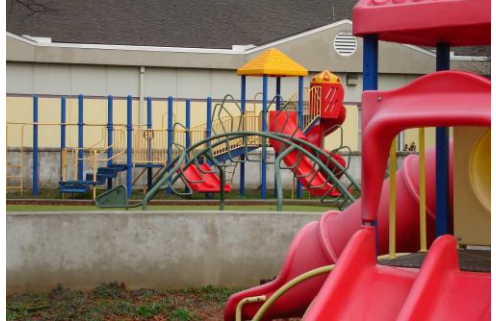
<p>Playground/Surfaces Equipment Status:</p> <p>Partially equipped Has antiquated rubber tuff surface</p>

<p>Playground Equipment / Surface Condition:</p> <p>Bad surface, needs to be replaced Enclosed courtyard</p>	 
<p>Playground/Surfaces Equipment Status:</p> <p>Partially equipped Has surface, Antiquated rubber tuff</p>	 
<p>Playground Equipment / Surface Condition:</p> <p>Bad, surface, needs to be replaced Enclosed courtyard</p>

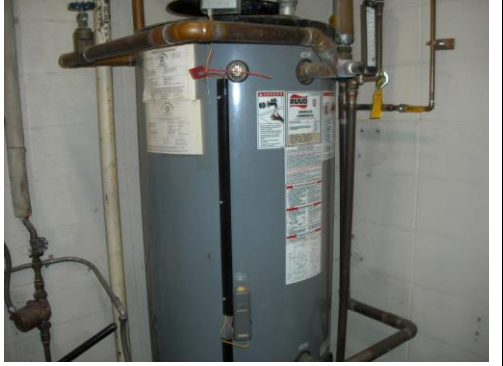
Description: Replace domestic hot water heater

Timeline: 2011-12	Cost: \$32,400

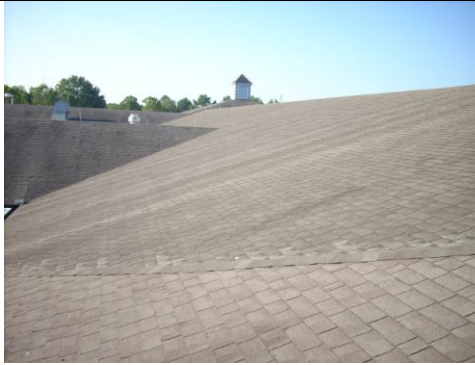
Description: Shingled roof: 14 years-poor

Timeline: TBD	Cost: \$3,000,000

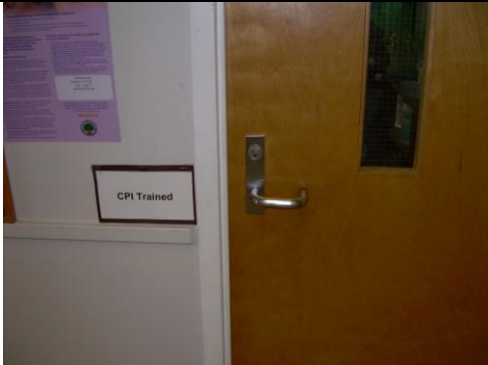
Description: Upgrade to ADA guidelines

Timeline: 2018-19	Cost: \$23,600

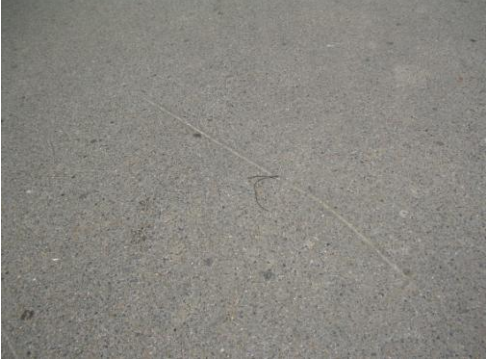
<p>Description:</p> <p>Crack patch, and overlay (16,367) sq. yd. of asphalt parking lot</p>

<p>Timeline:</p> <p>2011-12</p>	<p>Cost:</p> <p>\$221,280</p>
