2010 FACILITIES ASSESSMENT SPRING HILL ELEMENTARY

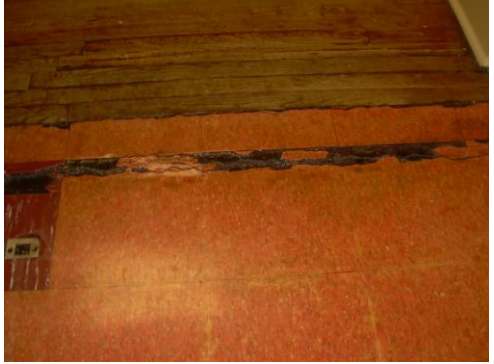
| <p>Description:</p> <p>Existing floor contains asbestos and is in poor condition.</p> | |

| <p>Timeline:</p> <p>TBD</p> | <p>Cost:</p> <p>\$58,000</p> |

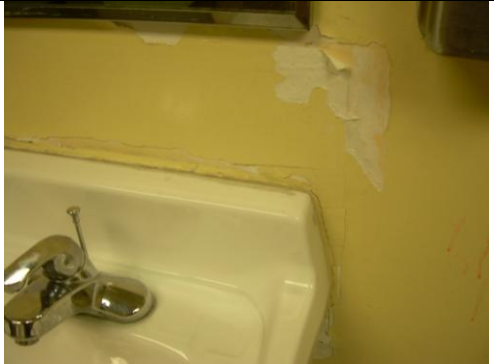
| <p>Description:</p> <p>Restrooms are in very poor condition, need painting, caulking and repairing.</p> | |

| <p>Timeline:</p> <p>TBD</p> | <p>Cost:</p> <p>\$13,000</p> |

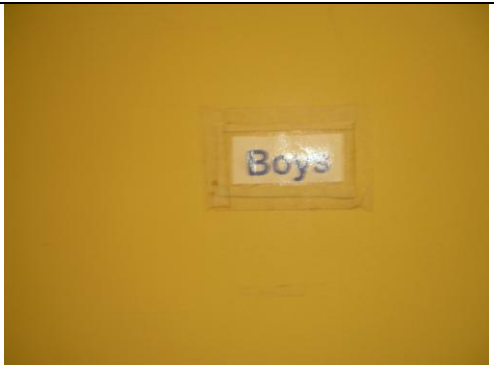
| <p>Description:</p> <p>Signage needed on some restrooms.</p> | |

| <p>Timeline:</p> <p>TBD</p> | <p>Cost:</p> <p>\$Minimal</p> |

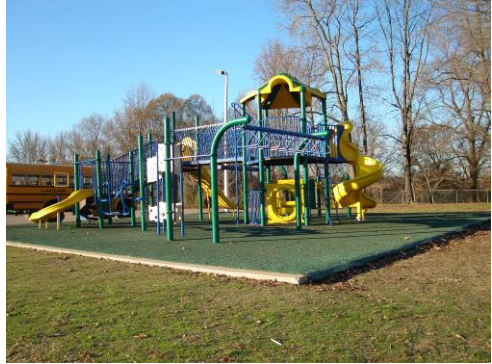
| <p>Playground/Surfaces Equipment Status:</p> <p>Fully equipped Has antiquated rubber tuff surface</p> <p>Playground Equipment / Surface Condition:</p> <p>New equipment, good condition Good surface No fence enclosure</p> | |

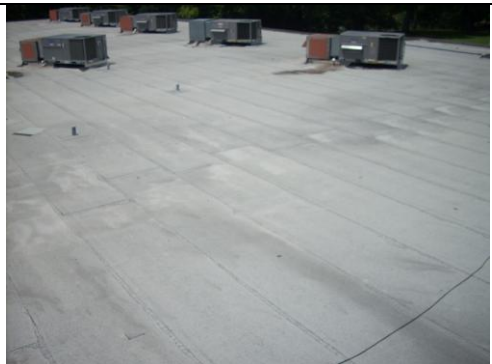
| <p>Description:</p> <p>Built up modified roof: 12 years-fair</p> <p>Built up with gravel: 12 years-fair</p> <p>Shingled roof: 12 years-fair</p> | |

| <p>Timeline:</p> <p>TBD</p> | <p>Cost:</p> <p>\$379,290</p> |

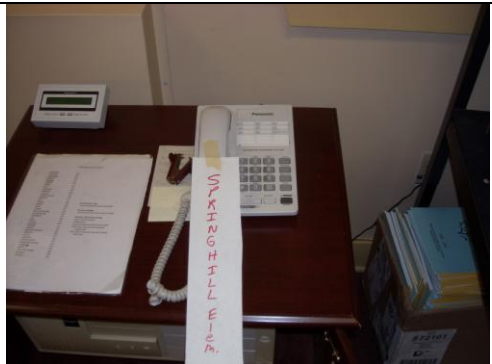
| <p>Description:</p> <p>Intercom System:</p> <p>Rauland Telecenter ICS</p> <p>Installation Date: 2002</p> | |

| <p>Timeline:</p> <p>TBD</p> | <p>Cost:</p> <p>\$50,000</p> |
