# 2010 FACILITIES ASSESSMENT DELANO ELEMENTARY

<b>Project Data</b>	
<b>Location Code:</b>	014
<b>Address:</b>	1716 Delano Rd
<b>Year Built:</b>	1957
<b>Grade Configuration:</b>	K-6
<b>Student Capacity:</b>	340/400
<b>Ideal Capacity:</b>	
<b>ADA Student Enrollment:</b>	9
<b>Size:</b>	0
<b>Portables:</b>	16.53 acres
<b>Building &amp; Addition</b>	3
	34,000 s. f.

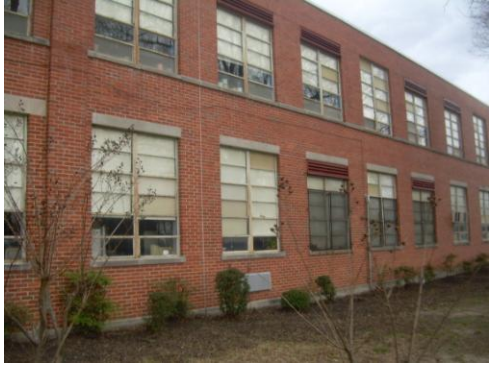
<b>Description:</b> Replace approximately (190) windows and store front entrances

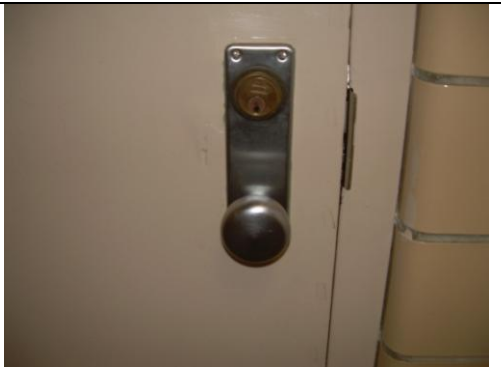
<b>Description:</b> Upgrade to ADA guidelines

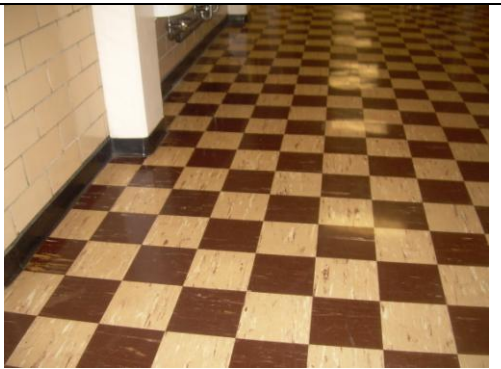
<b>Description:</b> Existing floor tile contains asbestos and is in poor condition.

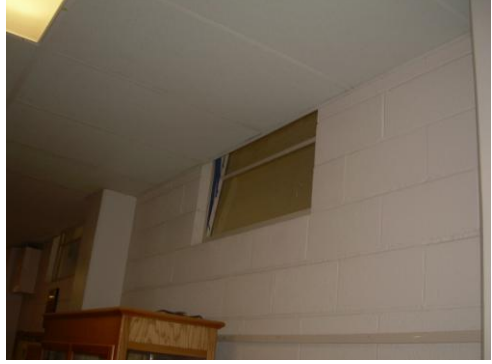
<p><b>Description:</b></p> <p>Transom windows do not provide code required 1 hour fire rating of compliance.</p>

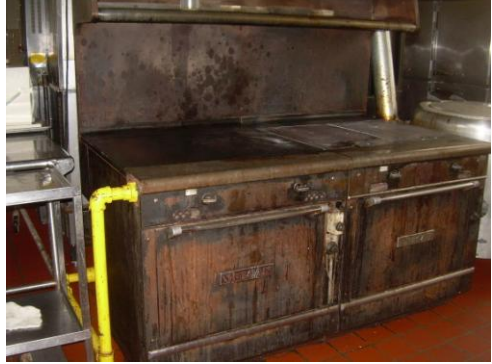
<p><b>Description:</b></p> <p>Kitchen equipment is old, in poor condition and not functioning properly.</p>

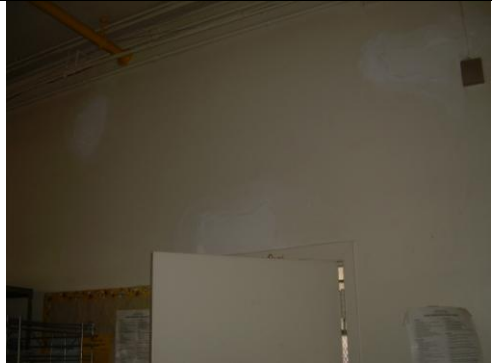
<p><b>Description:</b></p> <p>Paint interior of building</p>

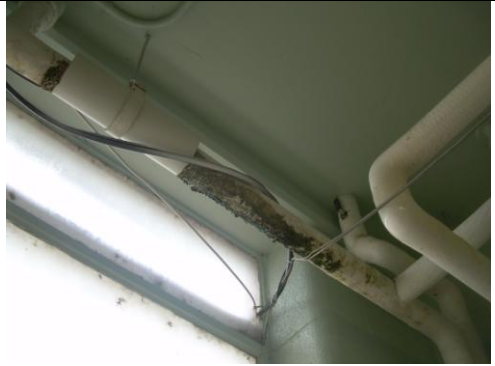
<b>Description:</b>  Pipe insulation in kitchen has mold damaged.

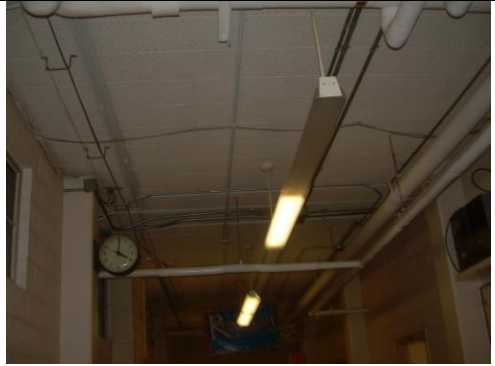
<b>Description:</b>  School has no sprinkler system.

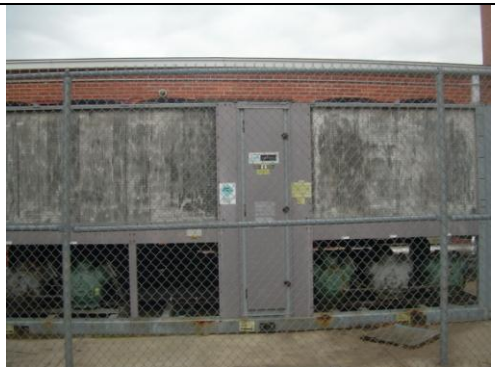
<b>Description:</b>  Chiller has exceeded its life expectancy.

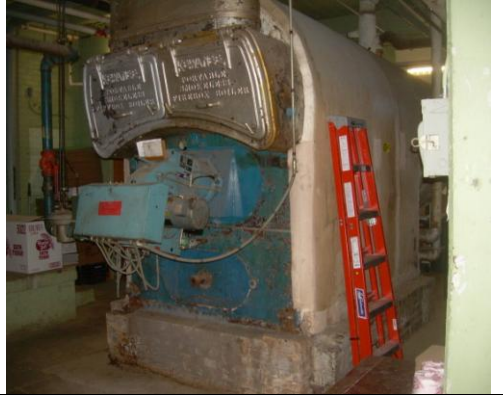
<p><b>Description:</b></p> <p>Boiler has met its life expectancy.</p>

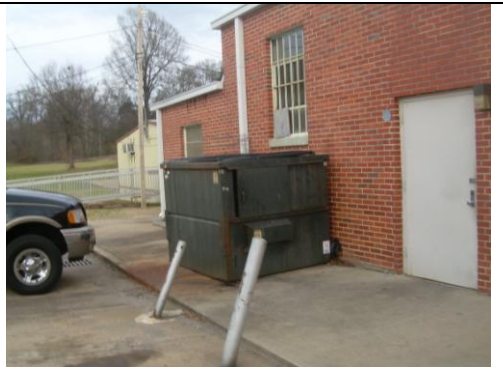
<p><b>Timeline:</b></p> <p>TBD</p>	<p>Cost</p> <p><b>\$90,000</b></p>
<p><b>Description:</b></p> <p>Dumpster has no enclosure.</p>

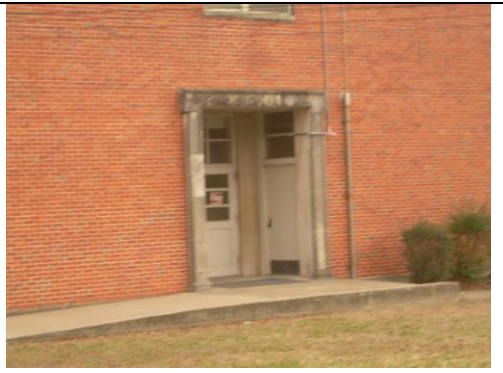
<p><b>Timeline:</b></p> <p>TBD</p>	<p>Cost</p> <p><b>\$35,000</b></p>
<p><b>Description:</b></p> <p>Clean, seal and paint exterior</p>

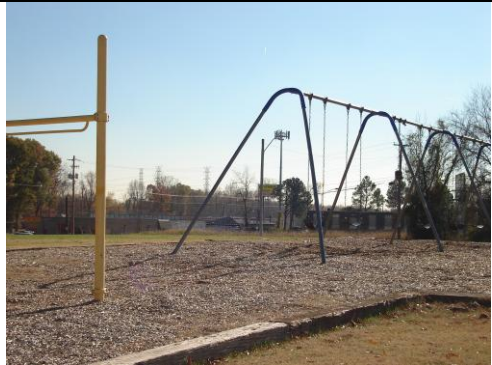
<p><b>Playground/Surfaces Equipment Status:</b></p> <p>Fully equipped Has woodchips w/ crossties border surface</p>

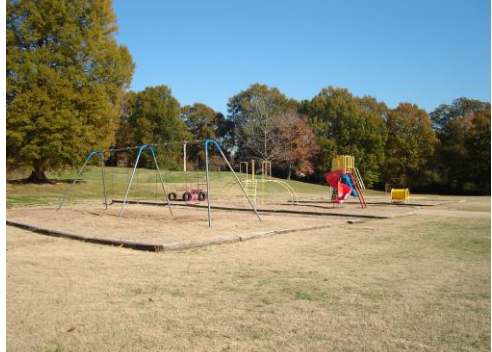
<p><b>Playground Equipment / Surface Condition:</b></p> <p>Used, but adequate Does not need replacing Surface adequate No fence enclosure</p>

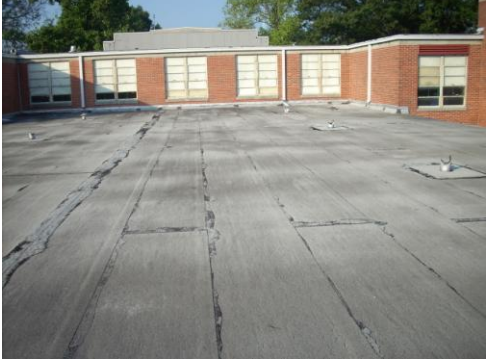
<p><b>Description:</b></p> <p>Built up modified roof: 15 years-poor</p>

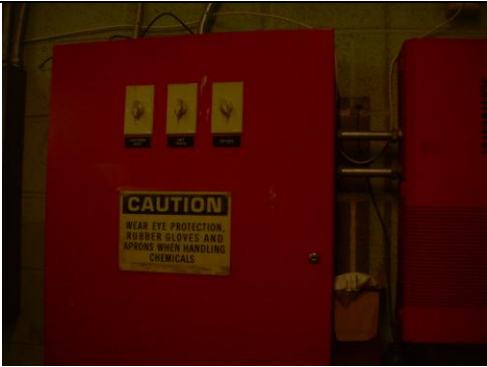
<p><b>Timeline:</b></p> <p>TBD</p>	<p><b>Cost</b></p> <p>\$165,000</p>
<p><b>Description:</b></p> <p>Replace EMS system and controls</p>

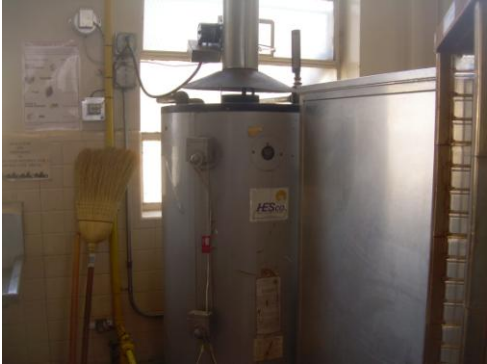
<p><b>Description:</b></p> <p>Replace domestic hot water tank</p>

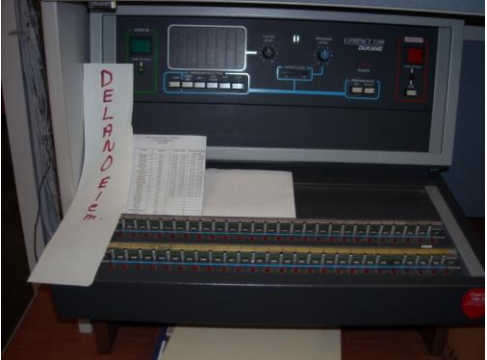
<p><b>Timeline:</b></p> <p><b>TBD</b></p>	<p>Cost</p> <p><b>\$41,600</b></p>
<p><b>Description:</b></p> <p>Intercom System:</p> <p>Dukane 3200</p> <p>Installation Date: 1997</p>
