2010 FACILITIES ASSESSMENT
DOUBLE TREE ELEMENTARY

Project Data	
Location Code:	221
Address:	4560 Double Tree
Year Built:	1977
Grade Configuration:	K-6
Student Capacity:	740/780
Ideal Capacity:	530
ADA Student Enrollment:	1
Size:	9.77 acres
Portables:	2
Building & Addition	52,872 s. f.

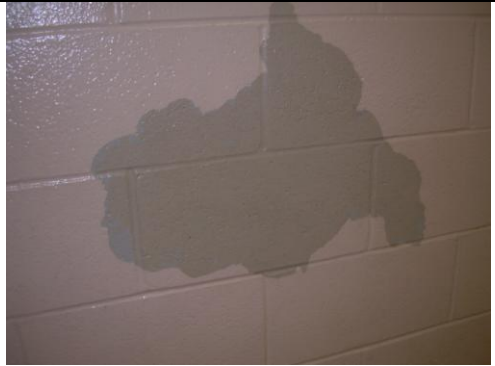
Timeline: 2010-11	Cost \$2,600
Description: Paint interior of building

Timeline: 2010-11	Cost \$74,200

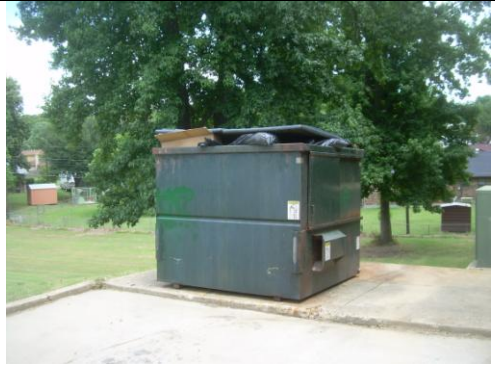
<p>Description:</p> <p>Dumpster does not have enclosure.</p>

<p>Timeline:</p> <p>2010-11</p>	<p>Cost</p> <p>\$5,000</p>

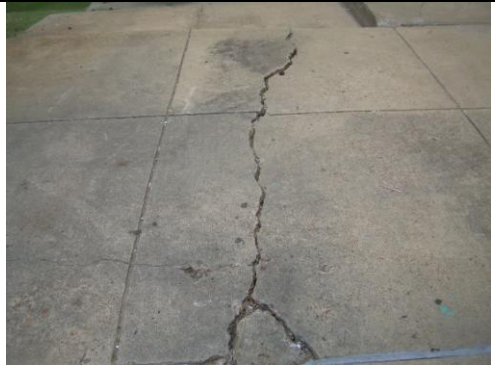
<p>Description:</p> <p>Pedestrian walkway is damaged / poor condition.</p>

<p>Timeline:</p> <p>2010-11</p>	<p>Cost</p> <p>\$14,000</p>

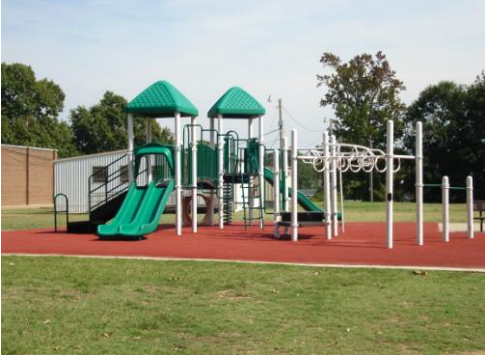
<p>Playground/Surfaces Equipment Status:</p> <p>Fully equipped Has surface (cast in place rubber)</p>

<p>Playground Equipment / Surface Condition:</p> <p>New equipment Good surface No fence enclosure</p>	
<p>Description:</p> <p>Intercom System: Rauland 350 Installation Date: 1985</p>
