2010 FACILITIES ASSESSMENT DUNBAR ELEMENTARY

Project Data	
Location Code:	017
Address:	2606 Select Avenue
Year Built:	1956
Grade Configuration:	K-5
Student Capacity:	600
Ideal Capacity:	415
ADA Student Enrollment:	0
Size:	
Portables:	63,307 s. f.
Building & additions	0

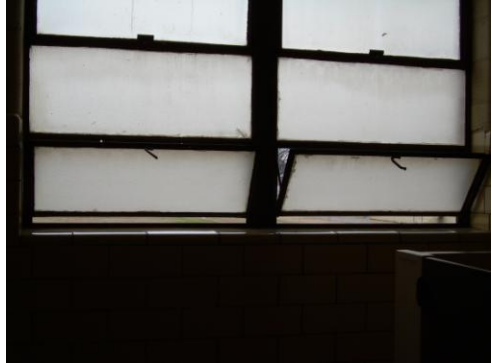
<p>Description:</p> <p>Window putty / glazing contain asbestos, windows not working properly and need replacing.</p>

<p>Timeline:</p> <p>2010-11</p>	<p>Cost</p> <p>\$400,000</p>

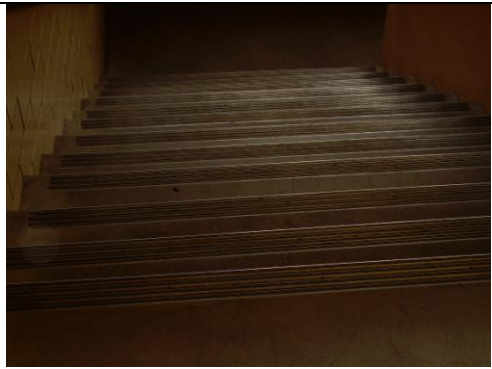
<p>Description:</p> <p>Stairwell treads have lost their integrity.</p>

<p>Timeline:</p> <p>TBD.</p>	<p>Cost:</p> <p>\$17,000</p>

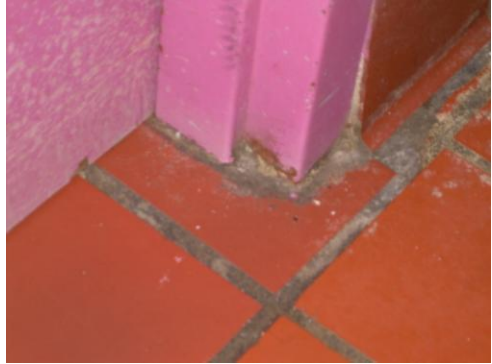
<p>Description:</p> <p>Door frames in kitchen are rusting creating health department issues.</p>

<p>Timeline:</p> <p>TBD</p>	<p>Cost</p> <p>\$2,700</p>

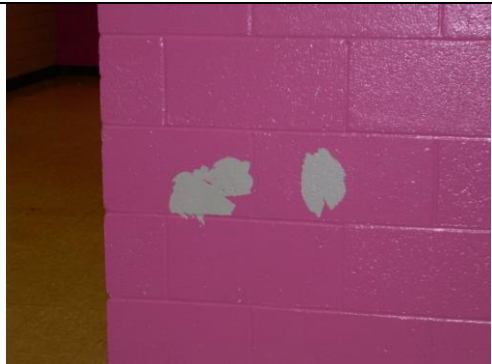
<p>Description:</p> <p>Interior paint in fair to good condition.</p>

<p>Timeline:</p> <p>TBD</p>	<p>Cost</p> <p>\$86,600</p>

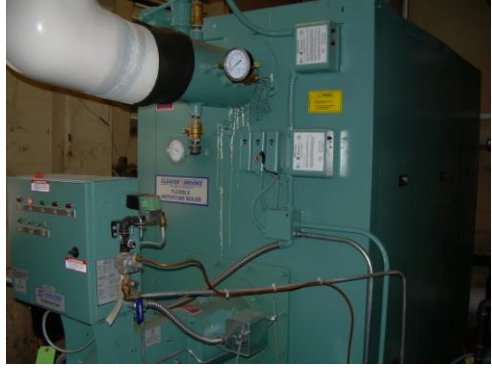
<p>Description:</p> <p>Replace HVAC controls</p>

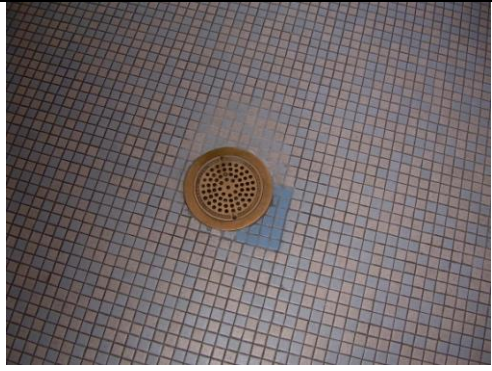
<p>Timeline:</p> <p>2010-11</p>	<p>Cost</p> <p>\$85,500</p>
<p>Description:</p> <p>Replace RR floor drains</p> <p>(Some drains have been replaced 3/10/2010)</p>

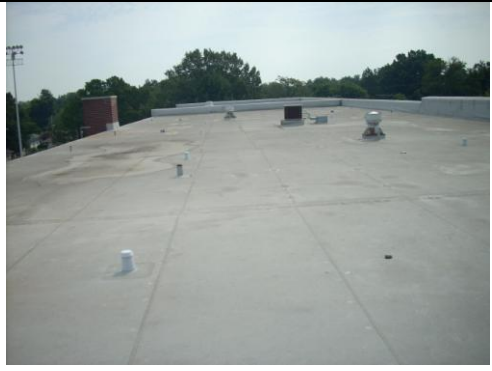
<p>Timeline:</p> <p>2010-11</p>	<p>Cost</p> <p>\$45,000</p>
<p>Description:</p> <p>PVC Single ply roof: 7 years-good</p> <p>Built up modified roof: 20 years-poor</p>

<p>Timeline:</p> <p>TBD</p>	<p>Cost</p> <p>\$135,000</p>
