2010 FACILITIES ASSESSMENT  
EAST CAREER & TECHNOLOGY CENTER

Project Data	
<b>Address:</b>	3206 Poplar
<b>Year Built:</b>	1976
<b>Grade Configuration:</b>	9-12
<b>Student Capacity:</b>	N/A
<b>Ideal Capacity:</b>	N/A
<b>ADA Student Enrollment:</b>	0
<b>Size:</b>	N/A
<b>Portables:</b>	0
<b>Building &amp; additions</b>	63,202 s. f.

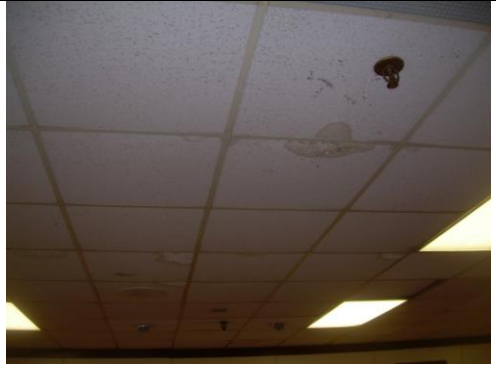
<p><b>Description:</b></p> <p>Ceiling tiles damaged in several locations.</p>

<p><b>Timeline:</b></p> <p><b>TBD</b></p>	<p><b>Cost</b></p> <p><b>Minimal</b></p>
<p><b>Description:</b></p> <p>Residual material (appears to be rust) on walls.</p>

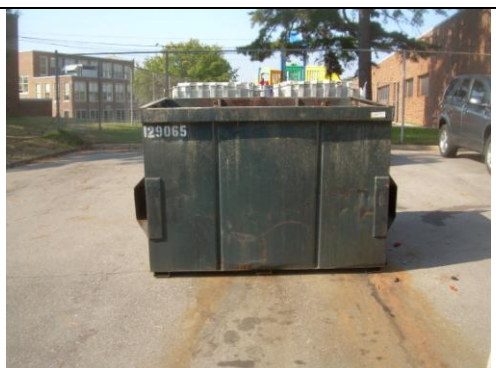
<p><b>Timeline:</b></p> <p><b>TBD</b></p>	<p><b>Cost</b></p> <p><b>Unknown</b></p>
<p><b>Description:</b></p> <p>Dumpster has no enclosure.</p>

<p><b>Timeline:</b></p> <p><b>TBD</b></p>	<p><b>Cost</b></p> <p><b>\$5,000</b></p>

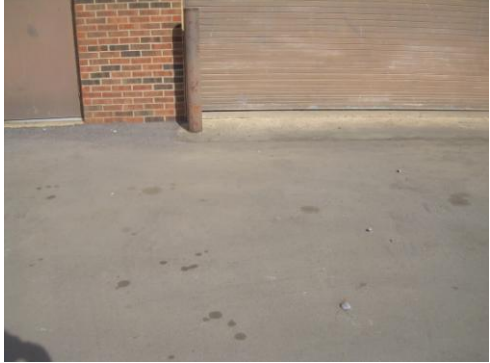
<p><b>Description:</b></p> <p>Water ponding in parking area in front of shop doors.</p>

<p><b>Timeline:</b></p> <p><b>TBD</b></p>	<p><b>Cost</b></p> <p><b>\$4,000</b></p>

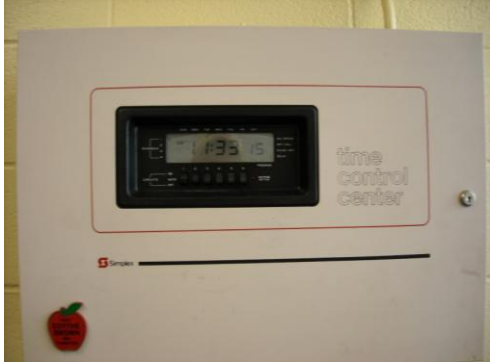
<p><b>Description:</b></p> <p>Replace clock/bell system</p>

<p><b>Timeline:</b></p> <p><b>2016-17</b></p>	<p><b>Cost</b></p> <p><b>\$36,700</b></p>

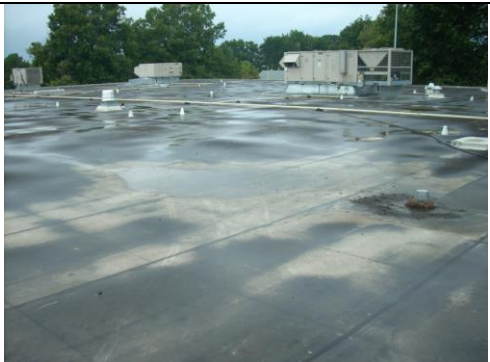
<p><b>Description:</b></p> <p>PVS Single Ply roof: 6 years-fair</p>

<p><b>Timeline:</b></p> <p><b>TBD</b></p>	<p><b>Cost</b></p> <p><b>\$255,000</b></p>
