2010 FACILITIES ASSESSMENT  
OAKHAVEN ELEMENTARY

Project Data	
<b>Location Code:</b>	108
<b>Address:</b>	3795 Bishops Bridge Road
<b>Year Built:</b>	1956
<b>Grade Configuration:</b>	K-6
<b>Student Capacity:</b>	800/1000
<b>Ideal Capacity:</b>	678
<b>ADA Student Enrollment:</b>	0
<b>Size:</b>	3 Acres
<b>Portables:</b>	6
<b>Building &amp; Addition</b>	56,522 ft2

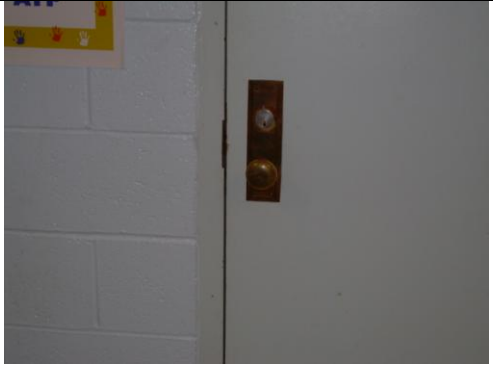
<b>Description:</b> Upgrade to ADA guidelines

<b>Timeline:</b> TBD	<b>Cost:</b> \$48,000

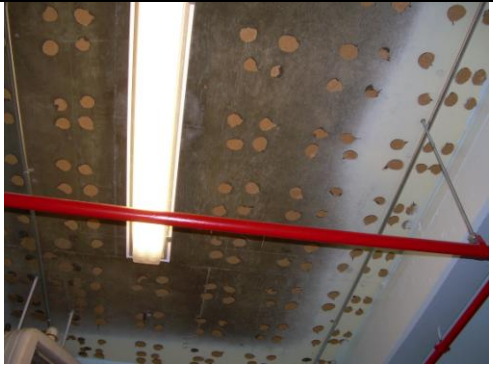
<b>Description:</b> Ceiling tile glue spots are exposed from missing ceiling tiles in stairwells.

<b>Timeline:</b> TBD	<b>Cost:</b> \$20,000

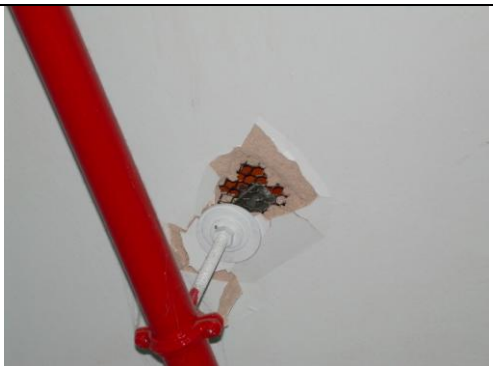
<b>Description:</b> Pipe support from ceiling has detached, safety hazard.

<b>Timeline:</b> TBD	<b>Cost:</b> \$250

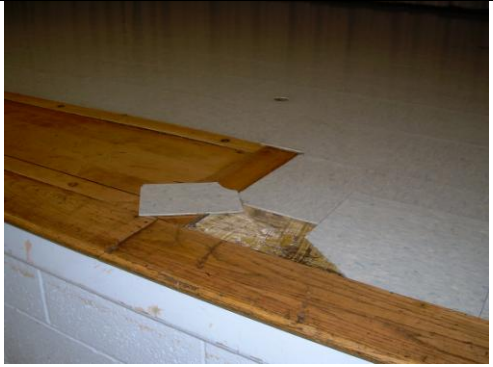
<b>Description:</b> Existing stage floor tile in poor condition.

<b>Timeline:</b> TBD	<b>Cost:</b> \$12,900

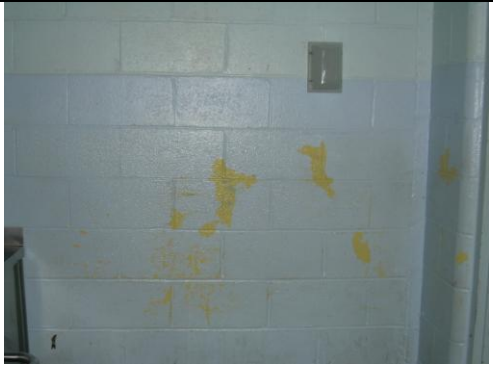
<b>Description:</b> Interior paint in facility is in fair to good condition.

<b>Timeline:</b> TBD	<b>Cost:</b> \$76,000

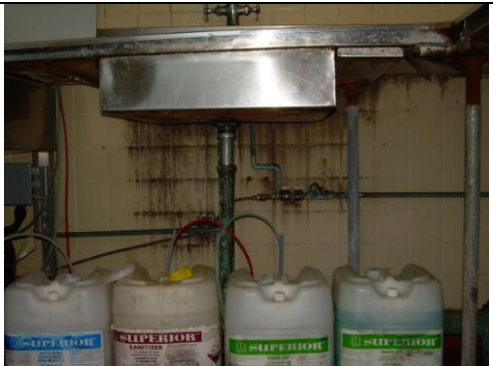
<b>Description:</b> Residual material on floor and wall of kitchen, creating health department issues.

<b>Timeline:</b> TBD	<b>Cost:</b> \$1,000

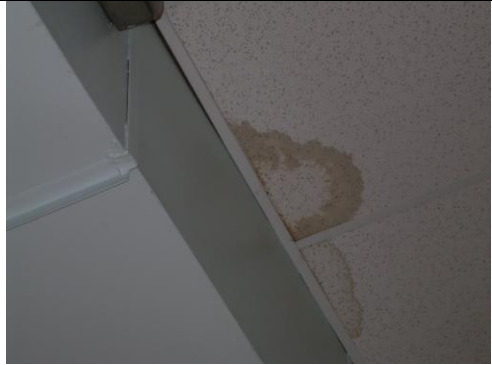
<p><b>Description:</b></p> <p>Lay-in ceiling tile in poor condition, mold is forming and causes potential health concerns.</p>

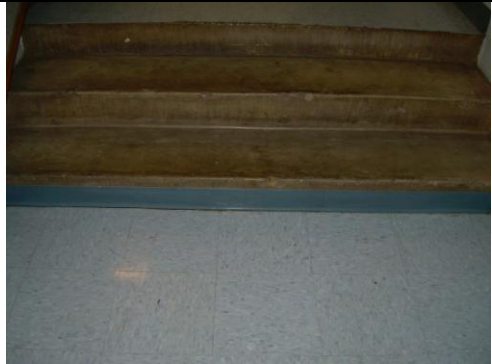
<p><b>Description:</b></p> <p>Stairwell treads have lost their integrity.</p>

<p><b>Timeline:</b></p> <p>TBD</p>	<p><b>Cost:</b></p> <p>\$17,000</p>

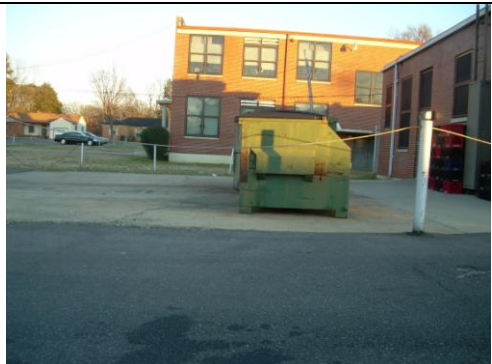
<p><b>Description:</b></p> <p>Dumpster has no enclosure</p>

<p><b>Timeline:</b></p> <p>TBD</p>	<p><b>Cost:</b></p> <p>\$5,000</p>

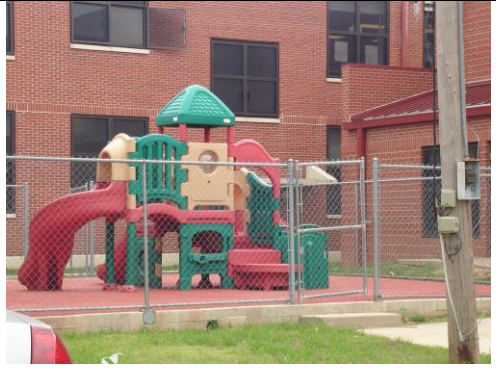
<p><b>Playground/Surfaces Equipment Status:</b></p> <p>Fully equipped Has cast in place rubber surface</p>

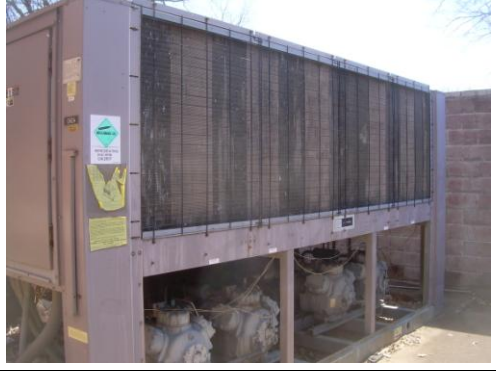
<p><b>Playground Equipment / Surface Condition:</b></p> <p>New equipment, good Good surface No fence enclosure</p>	
<p><b>Description:</b></p> <p>Replace air cooled chillers, (34) unit ventilators, (11) FCU and (7) RTU</p>

<p><b>Timeline:</b></p> <p><b>2015-16</b></p>	<p><b>Cost:</b></p> <p><b>\$2,128,000</b></p>
<p><b>Description:</b></p> <p>Replace domestic water heater and tank</p>

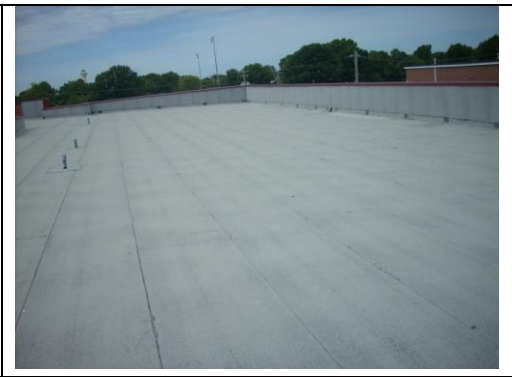
<p><b>Description:</b></p> <p>Built up modified roof: 17 years-fair</p>

<p><b>Timeline:</b></p> <p><b>TBD</b></p>	<p><b>Cost:</b></p> <p><b>\$167,500</b></p>

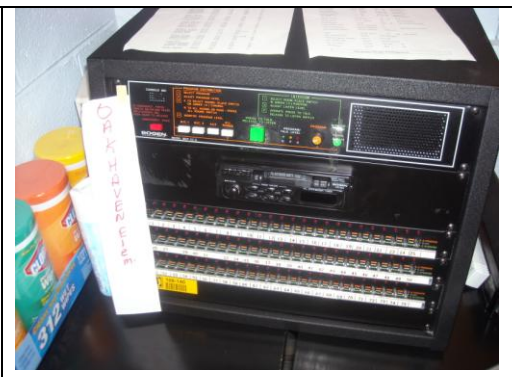
<p><b>Description:</b></p> <p>Oakhaven Elem.</p> <p>Bogen MCP35A</p> <p>Installation Date:</p>

<p><b>Timeline:</b></p> <p><b>TBD</b></p>	<p><b>Costs:</b></p> <p><b>\$50,000</b></p>
