2010 FACILITIES ASSESSMENT  
GEORGIAN HILLS MIDDLE

<b>Project Data</b>	
<b>Location Code:</b>	114
<b>Address:</b>	3925 Denver Rd
<b>Year Built:</b>	1959
<b>Grade Configuration:</b>	7-8
<b>Student Capacity:</b>	775/850
<b>Ideal Capacity:</b>	536
<b>ADA Student Enrollment:</b>	0
<b>Size:</b>	17.34 acres
<b>Portables:</b>	1
<b>Building &amp; Addition</b>	87,069 sf.

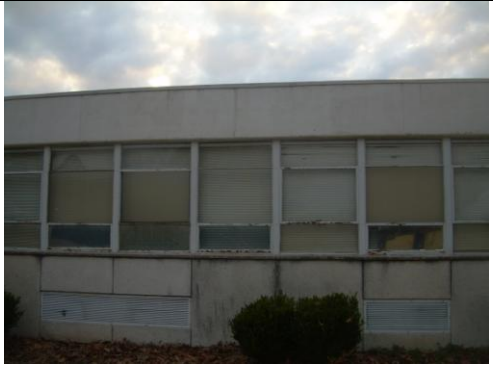
<b>Description:</b>  Window putty / glazing contain asbestos, windows not working properly and needs replacing.

<b>Timeline:</b>  TBD	<b>Cost:</b>  \$312,000

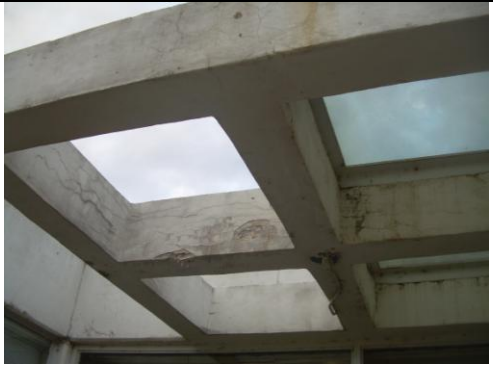
<b>Description:</b>  Existing exterior need pressure washing.

<b>Timeline:</b>  TBD	<b>Cost:</b>  \$4,000

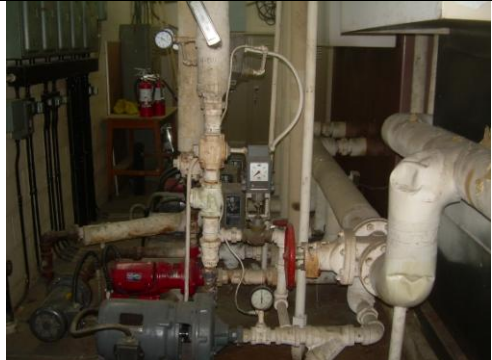
<p><b>Description:</b></p> <p>Thermal pipe insulation in boiler room contains asbestos and is in poor condition.</p>

<p><b>Timeline:</b></p> <p>TBD</p>	<p><b>Cost:</b></p> <p>\$8,000</p>

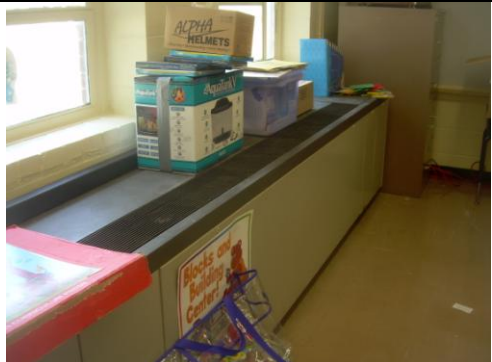
<p><b>Description:</b></p> <p>Self contained unit ventilators do not operate properly. History of costly maintenance issues.</p>

<p><b>Timeline:</b></p> <p>TBD</p>	<p><b>Cost:</b></p> <p>\$1,112,000</p>

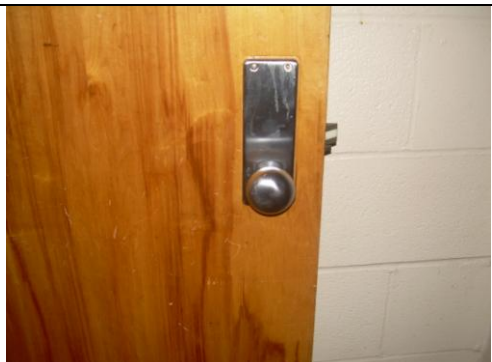
<p><b>Description:</b></p> <p>Upgrade to ADA guidelines</p>

<p><b>Timeline:</b></p> <p>TBD</p>	<p><b>Cost:</b></p> <p>\$98,000</p>

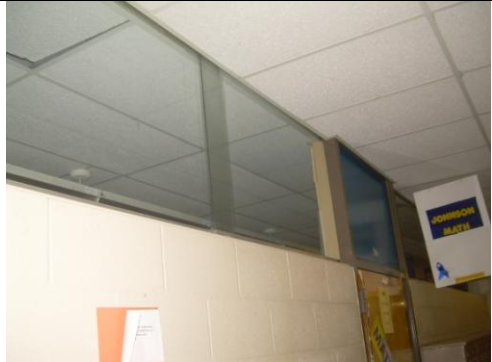
<p><b>Description:</b></p> <p>Transom windows do not provide code required 1 hour fire rating of compliance.</p>

<p><b>Timeline:</b></p> <p><b>TBD</b></p>	<p><b>Cost:</b></p> <p><b>\$21,000</b></p>

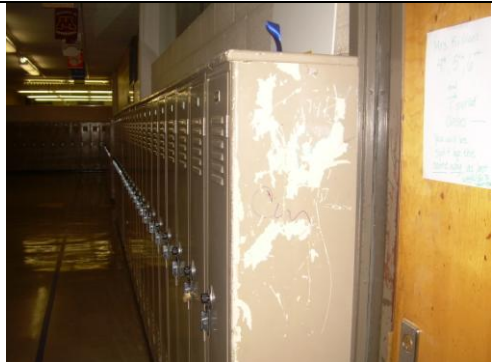
<p><b>Description:</b></p> <p>Lockers need painting.</p>

<p><b>Timeline:</b></p> <p><b>TBD</b></p>	<p><b>Cost:</b></p> <p><b>\$8,000</b></p>

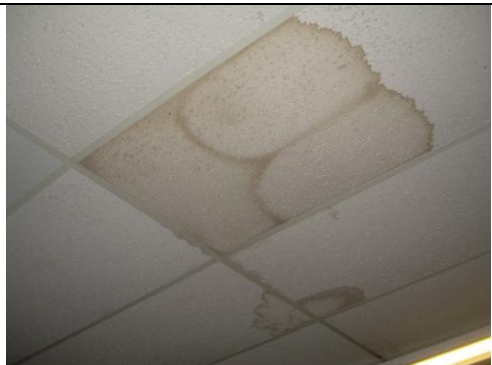
<p><b>Description:</b></p> <p>Lay-in ceiling tile in poor condition, mold forms and cause potential health concerns</p>

<p><b>Timeline:</b></p> <p><b>TBD</b></p>	<p><b>Cost:</b></p> <p><b>\$10,000</b></p>

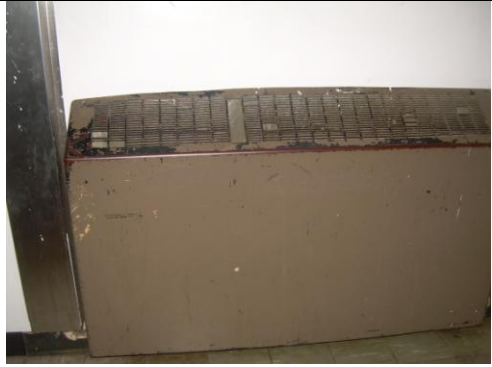
<p><b>Description:</b></p> <p>Hallway radiators are damaged and in overall poor condition.</p>

<p><b>Timeline:</b></p> <p><b>TBD</b></p>	<p><b>Cost:</b></p> <p><b>\$40,000</b></p>

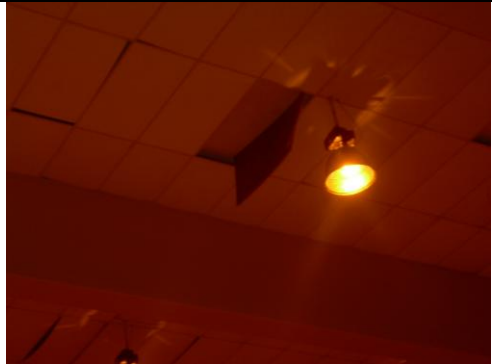
<p><b>Description:</b></p> <p>Existing ceiling tile in gymnasium are in poor condition and hanging from the ceiling causing safety concerns and issues.</p>

<p><b>Timeline:</b></p> <p><b>TBD</b></p>	<p><b>Cost:</b></p> <p><b>\$10,000</b></p>

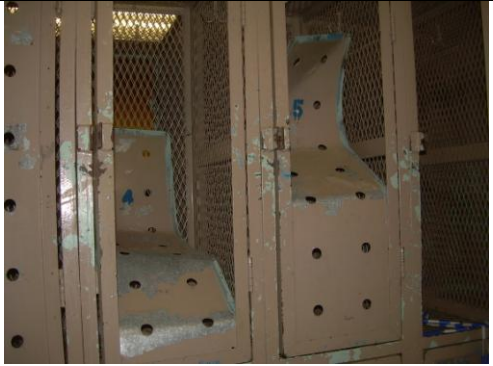
<b>Description:</b>  Existing locker room lockers in poor condition, broken and etc.

<b>Timeline:</b>  TBD	<b>Cost:</b>  \$20,000

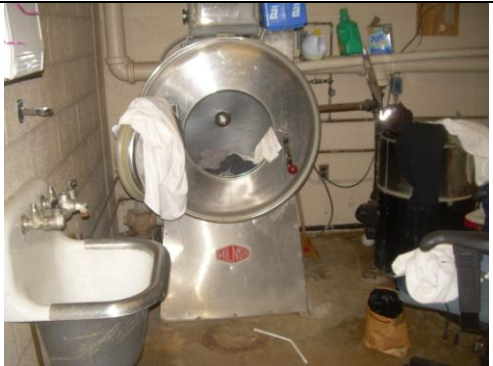
<b>Description:</b>  Washing machine in gym laundry room does not work.

<b>Timeline:</b>  TBD	<b>Cost:</b>  \$14,000

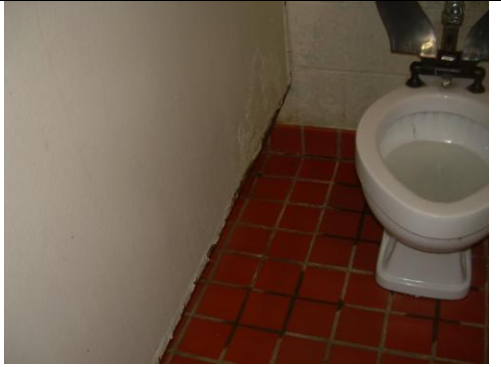
<b>Description:</b>  Restroom stall walls are starting to rust and are in poor condition overall.

<b>Timeline:</b>  TBD	<b>Cost:</b>  \$109,000

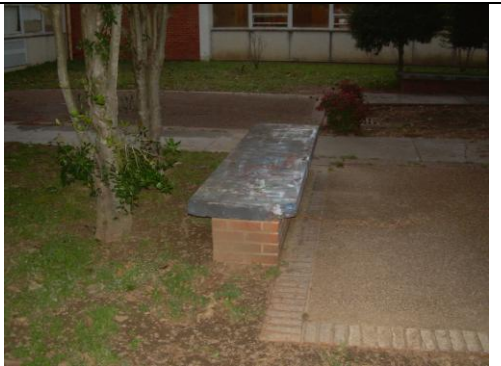
<b>Description:</b>  Exterior of building - bench in poor condition and requires painting.

<b>Timeline:</b>  TBD	<b>Cost:</b>  \$200

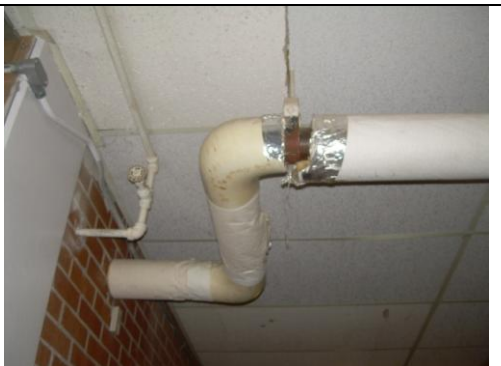
<b>Description:</b>  Pipe insulation in poor condition and needs replacing or repairing.

<b>Timeline:</b>  TBD	<b>Cost:</b>  \$3,000

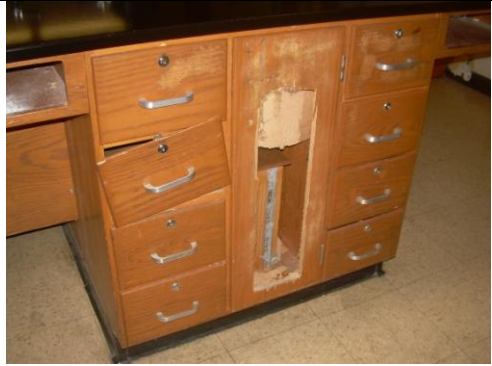
<p><b>Description:</b></p> <p>Existing lab desks are in poor condition, need painting and / or have broken parts.</p>

<p><b>Timeline:</b></p> <p><b>TBD</b></p>	<p><b>Cost:</b></p> <p><b>\$80,000</b></p>

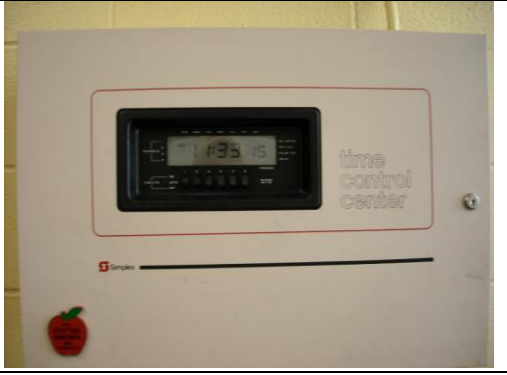
<b>Description:</b> Replace EMS system and controls

<b>Timeline:</b> 2011-12	<b>Cost:</b> \$312,000

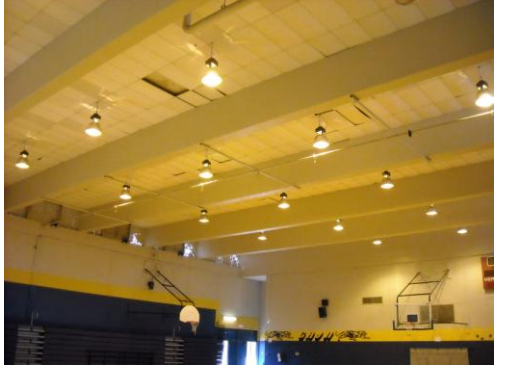
<b>Description:</b> Replace gymnasium lighting

<b>Timeline:</b> 2013-14	<b>Cost:</b> \$31,400
