2010 FACILITIES ASSESSMENT SHARPE ELEMENTARY

Project Data

Location Code:	055
Address:	3431 Sharpe
Year Built:	1955
Grade Configuration:	K-5
Student Capacity:	540/600
Ideal Capacity:	420
ADA Student Enrollment:	0
Size:	5.82 acres
Portables:	2
Building & Addition:	47,130 s. f.

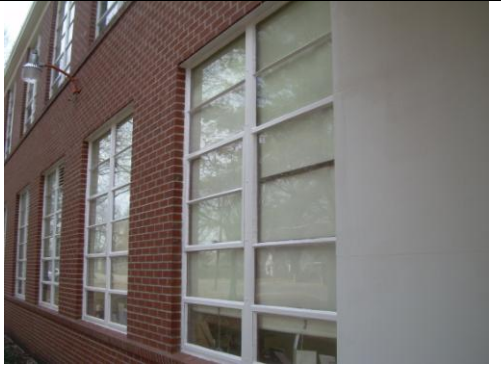
Description: Window putty / glazing contain asbestos, windows not working properly and need replacing.

Timeline: TBD	Cost: \$268,000

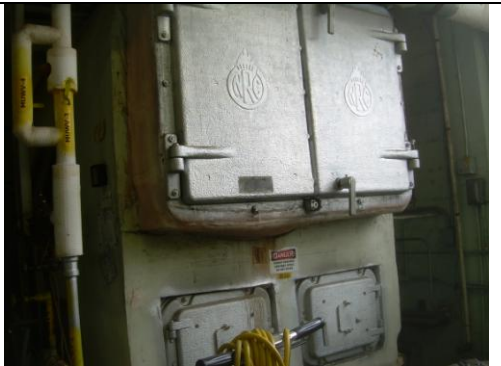
Description: Boiler room has excessive amount of asbestos insulating materials including the boiler insulation, as well as on piping- All in poor condition.

Timeline: TBD	Cost: \$12,000

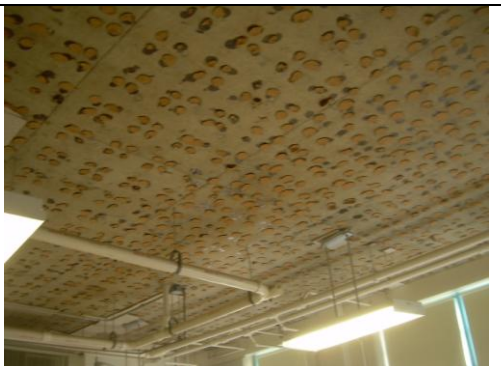
Description: Ceiling tile glue spots are exposed from missing ceiling tile.

Timeline: TBD	Cost: \$400,000

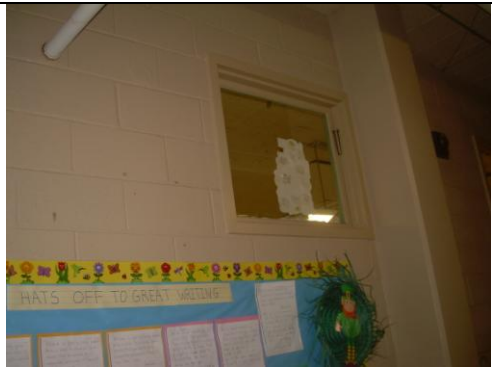
<p>Description:</p> <p>Transom windows do not provide code required 1 hour fire rating of compliance.</p>

<p>Timeline:</p> <p>TBD</p>	<p>Cost:</p> <p>\$6,000</p>

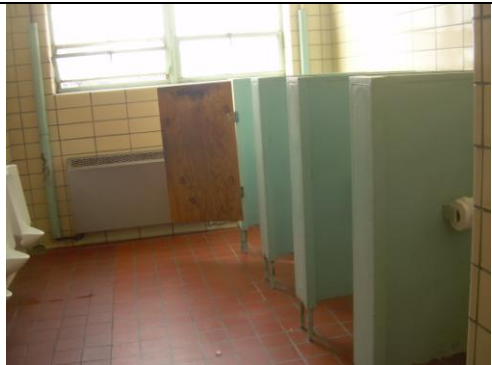
<p>Description:</p> <p>Bathroom stall doors are missing.</p>

<p>Timeline:</p> <p>TBD</p>	<p>Cost:</p> <p>\$3,000</p>

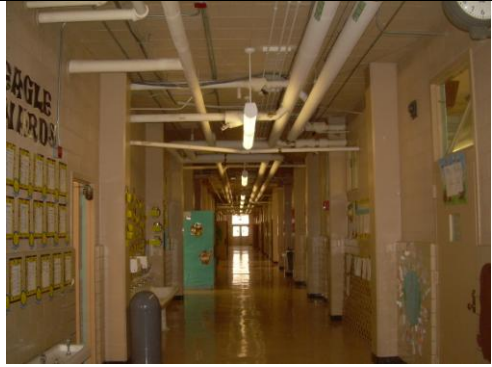
<p>Description:</p> <p>Hallway ceiling is aesthetically unattractive.</p>

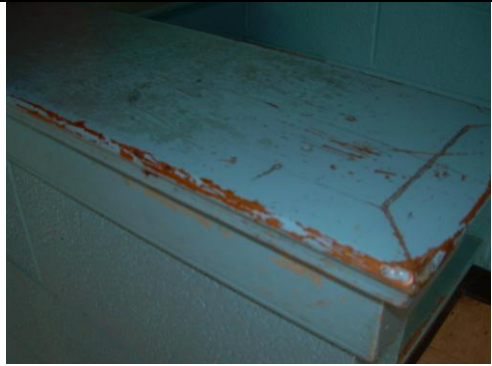
<p>Timeline:</p> <p>TBD</p>	<p>Cost:</p> <p>Included in previous</p>
<p>Description:</p> <p>Interior paint in poor condition.</p>

<p>Timeline:</p> <p>TBD</p>	<p>Cost:</p> <p>\$66,000</p>
<p>Description:</p> <p>See previous item.</p>

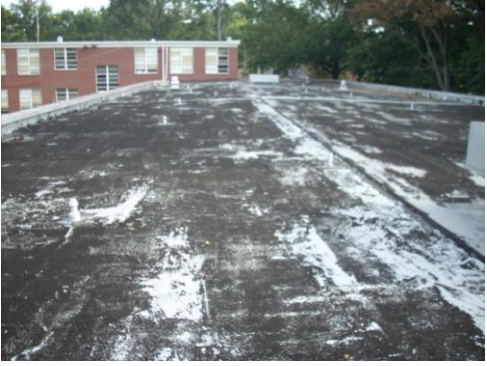
<p>Description:</p> <p>Built up modified roof: 17 years-poor</p>

<p>Timeline:</p> <p>TBD</p>	<p>Cost:</p> <p>\$139,500</p>

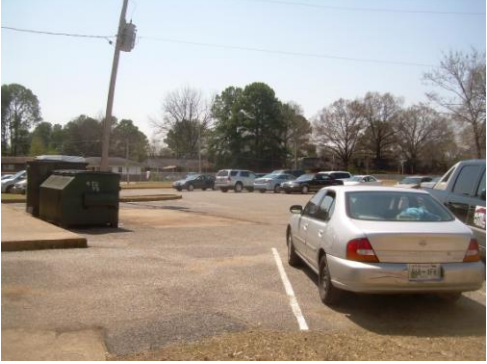
<p>Description:</p> <p>Patch and overlay (4,035) sq. yd. of asphalt parking lot</p>

<p>Timeline:</p> <p>2010-11</p>	<p>Cost:</p> <p>\$45,000</p>

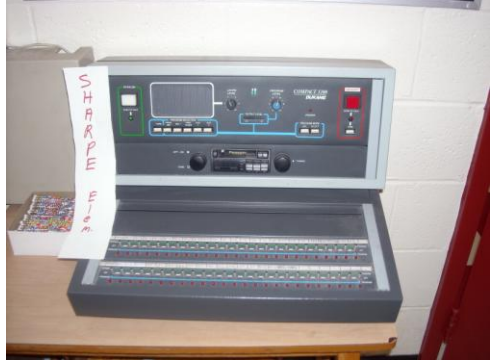
<p>Description:</p> <p>Intercom System:</p> <p>Dukane 3200</p> <p>Installation Date: 1994</p>

<p>Timeline:</p> <p>TBD</p>	<p>Costs:</p> <p>\$50,000</p>
