2010 FACILITIES ASSESSMENT  
WINCHESTER ELEMENTARY

<b>Location Code:</b>	209
<b>Address:</b>	3587 Boeingshire
<b>Year Built:</b>	1960
<b>Grade Configuration:</b>	K-5
<b>Student Capacity:</b>	700/780
<b>Ideal Capacity:</b>	685
<b>ADA Student Enrollment:</b>	0
<b>Size:</b>	16 Acres
<b>Portables:</b>	0
<b>Building &amp; Additions:</b>	86,984 s. f.

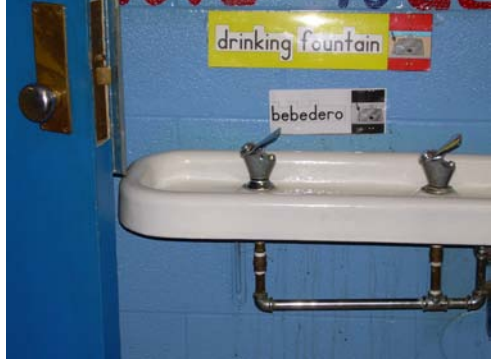
<p><b>Description:</b></p> <p>Upgrade to ADA guidelines.</p>

<p><b>Timeline:</b></p> <p><b>TBD</b></p>	<p><b>Cost:</b></p> <p><b>\$26,000</b></p>

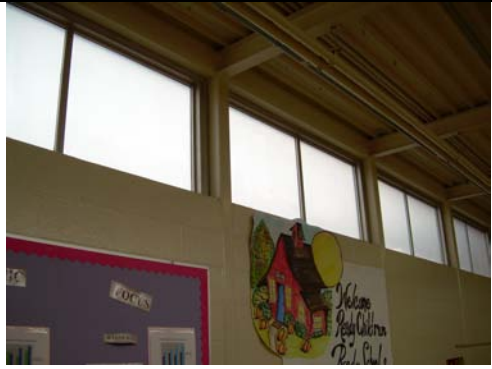
<p><b>Description:</b></p> <p>Transom windows do not provide code required 1 hour fire rating of compliance.</p>

<p><b>Timeline:</b></p> <p><b>TBD</b></p>	<p><b>Cost:</b></p> <p><b>\$12,000</b></p>

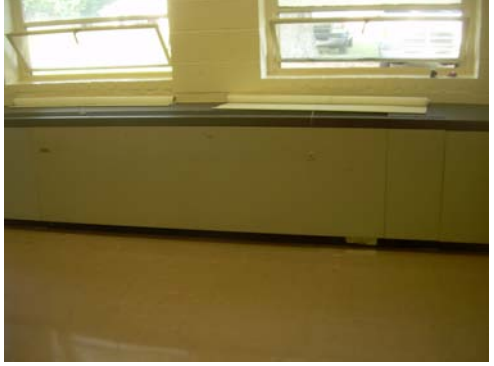
<b>Description:</b>  Self contained unit ventilators do not operate properly. History of costly maintenance issues.

<b>Timeline:</b>  <b>TBD</b>	<b>Cost:</b>  <b>\$950,000</b>

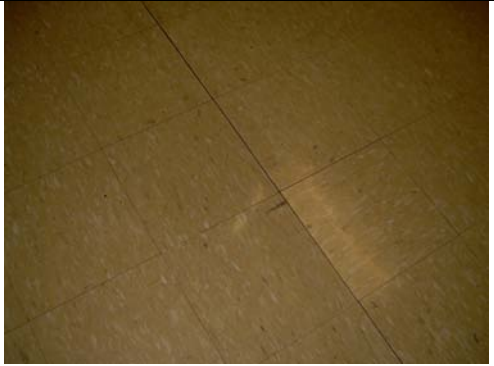
<b>Description:</b>  Existing floor tile contains asbestos and are in poor condition.

<b>Timeline:</b>  <b>TBD</b>	<b>Cost:</b>  <b>\$196,000</b>

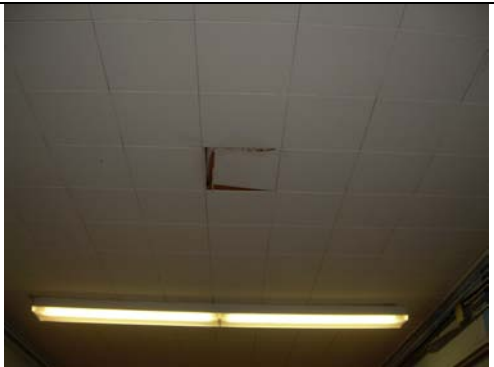
<b>Description:</b>  Existing 12"x12" ceiling tiles in poor condition.

<b>Timeline:</b>  <b>TBD</b>	<b>Cost:</b>  <b>\$120,000</b>

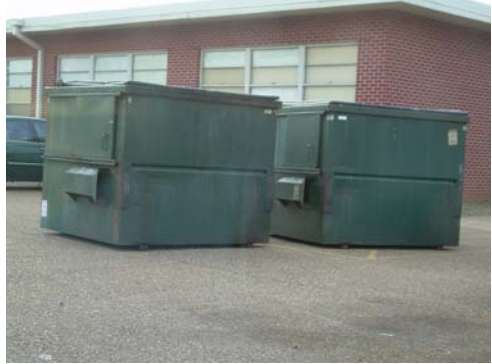
<b>Description:</b>  Dumpsters (2) need enclosure.

<b>Timeline:</b>  TBD	<b>Cost:</b>  \$10,000

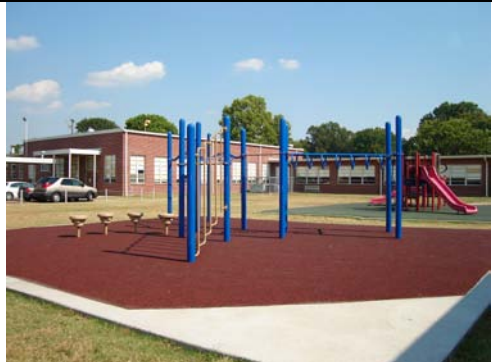
<b>Playground/Surfaces Equipment Status:</b>  Fully equipped Has cast in place rubber surface

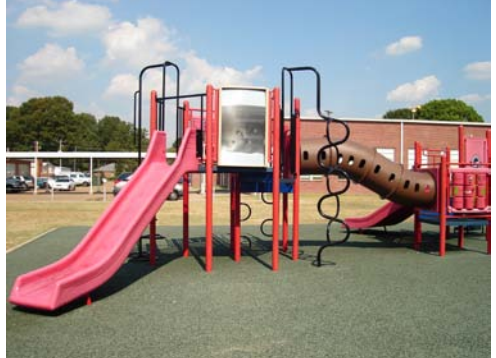
<p><b>Playground Equipment / Surface Condition:</b></p> <p>New equipment, good Good surface Inside courtyard, not enclosed</p>

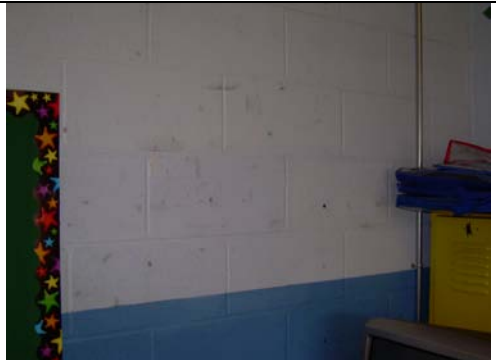
<p><b>Description:</b></p> <p>Paint interior of building</p>

<p><b>Timeline:</b></p> <p><b>2012-13</b></p>	<p><b>Cost:</b></p> <p><b>\$118,700</b></p>
-----------------------------------------------	---------------------------------------------

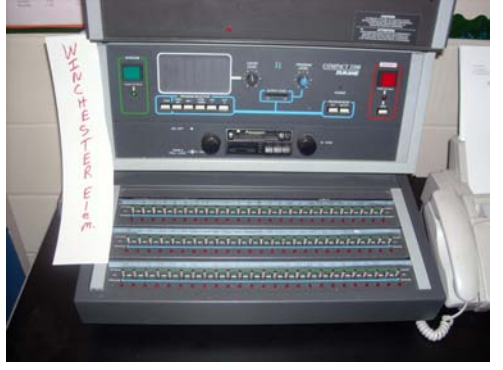
<p><b>Description:</b></p> <p>Intercom System:</p> <p>Dukane 3200</p> <p>Installation Date: 1996</p>

<p><b>Timeline:</b></p> <p><b>TBD</b></p>	<p><b>Cost:</b></p> <p><b>\$50,000</b></p>
